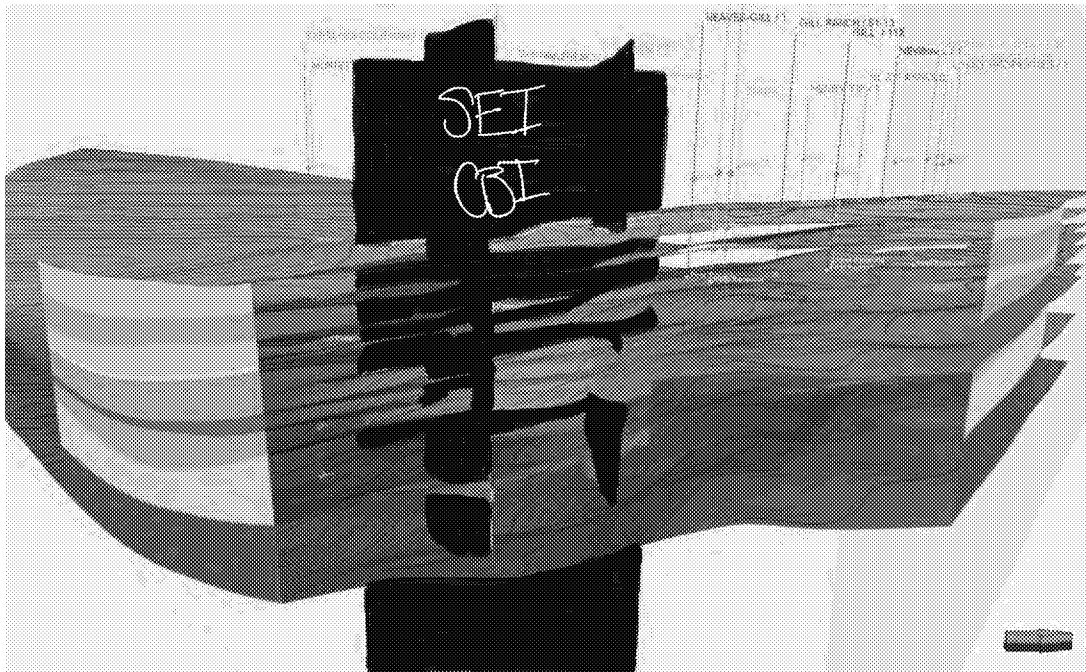
Figure 20: **CONFIDENTIAL BUSINESS INFORMATION:** 3D perspective of the depth integrated geophysical model. This image displays (SEI, 2019) data and it is marked as Confidential Business Information.

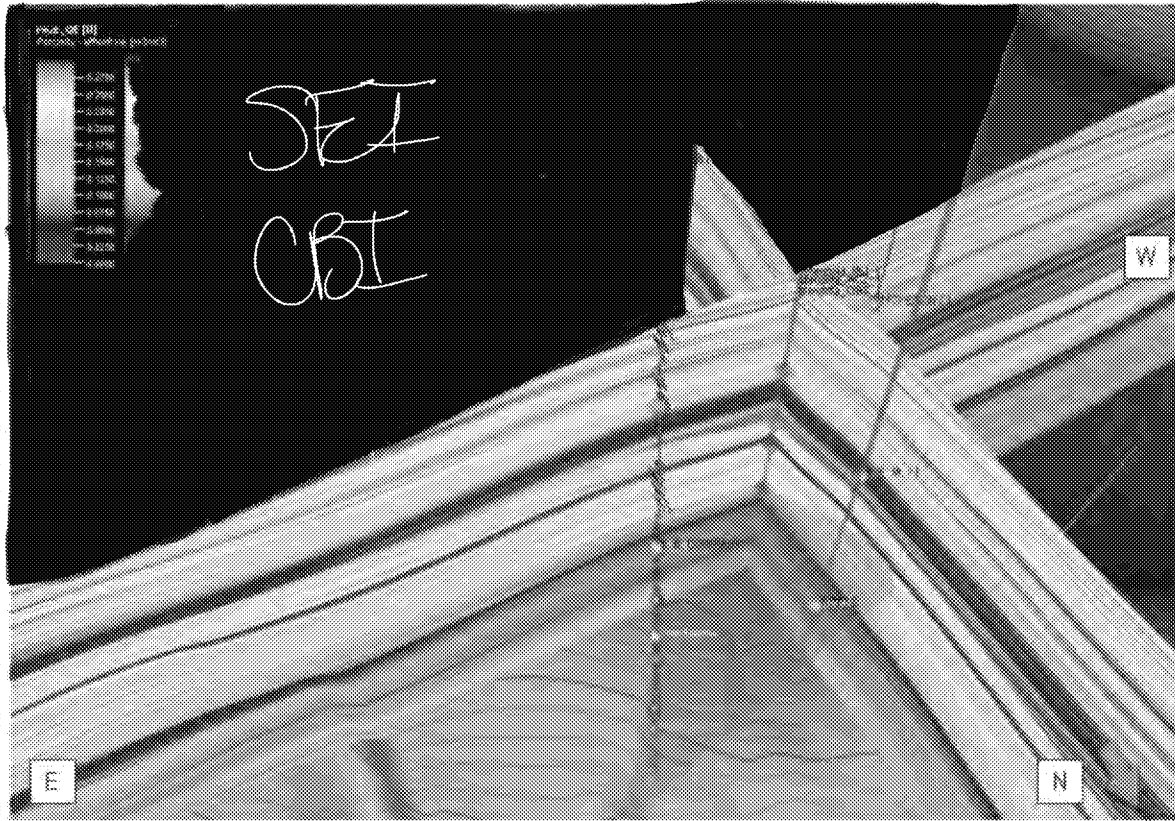
Figure 33: **CONFIDENTIAL BUSINESS INFORMATION:** 3D Perspective of N-S and E-W porosity cross-sections at Mendota_INJ_1. This image displays (SEI, 2019) data and it is marked as Confidential Business Information.
